Improving Motor Performance and Runtime in ESP applications with Novel Sinewave Filter

SPE-204493-MS

Anthony (Tony) Hoevenaars and Mike McGraw, Mirus International and Colt Burley and Elizabeth Bierhaus, Denbury Onshore LLC

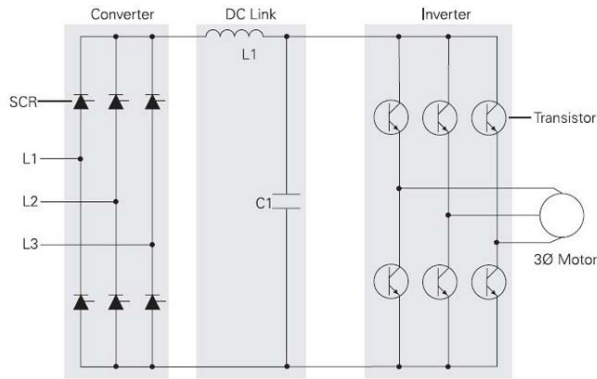
Fig. 1 Schematic Diagram for Typical 6-Step VSD with SCR Rectifier

In their early years, adjustable speed drives operated as Current Source Input (CSI) or Variable Voltage Input (VVI) because the power devices available at the time did not offer high switching frequencies. Fig. 1 shows a typical VVI VSD schematic often referred to as 6-Step because six 60° steps are used to produce the output voltage in one complete 360° cycle (Fig. 2). As seen, the resultant voltage waveform is not sinusoidal, often with total harmonic distortion above 20%. AC motors can normally operate fine with this input voltage, provided no additional distortion is introduced from the application. In addition, the DC bus voltage must be controlled which requires an SCR input rectifier bridge rather than a simple diode bridge rectifier. This in turn, can introduce higher levels of input current harmonics, lower input power factor and voltage notching on the upstream distribution equipment.

For ESP applications, 6-Step drives are still often used because switching at lower frequencies can reduce the negative effects of the long cable runs between the drive and motor. By minimizing the number of switches in a cycle and reducing the magnitude of the change in voltage, the number and magnitude of voltage transients are reduced in kind. Despite this, destructive over-voltages can still be present and additional heat is generated in the motor.

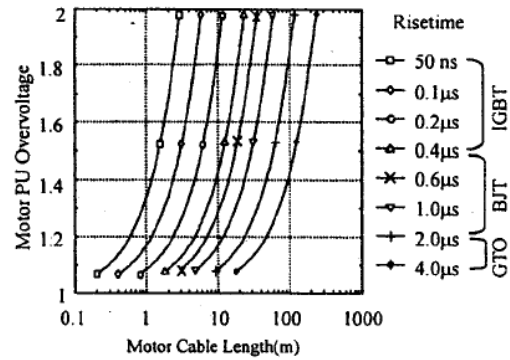
Fig. 6 Motor PU Overvoltage vs Cable Length and Rise Time [8]

Fig. 6 shows estimated values of per unit (PU) voltage increase with respect to cable length and PWM pulse rise time [8]. Older slow switching devices produce lower over-voltages at longer distances. With their higher switching speeds, IGBTs introduce over-voltages at shorter cable lengths. Since most ESP installations are installed hundreds, even thousands of meters deep, the potential for a 2x PU voltage increase can generally be assumed. These over-voltages can lead to stresses on the motor insulation system resulting in reduced motor life.

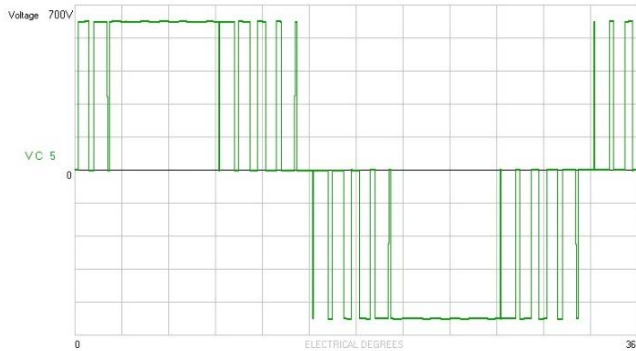
Fig. 11a Inverter Output PWM Voltage Waveform at 2 kHz Switching Frequency

Initial analysis was done for a 200 HP, 480V, 60 Hz ESP system. Figures 11a and b show inverter output voltage waveform and spectrum switching at 2 kHz. As expected, predominant harmonics are at the switching frequency and multiples of that frequency. Performance of the filter in reduction of switching frequency harmonics was quite poor with the filter tuned to 600 Hz – 10x the output frequency which conventional design practice recommends. vTHD (Voltage Total Harmonic Distortion) was nearly 9.1% (Fig. 11c and d) and iTHD (Current Total Harmonic Distortion) above 8.7% (Fig. 11e and f). This would indicate a resonance condition exists when tuned near 600 Hz. Adding resistors to the filter helped reduce the resonance but not enough to be comfortable with the design. Similar results were achieved for the 1100 HP, 480V, 60 Hz ESP system when designed for a tuned frequency of 600 Hz.

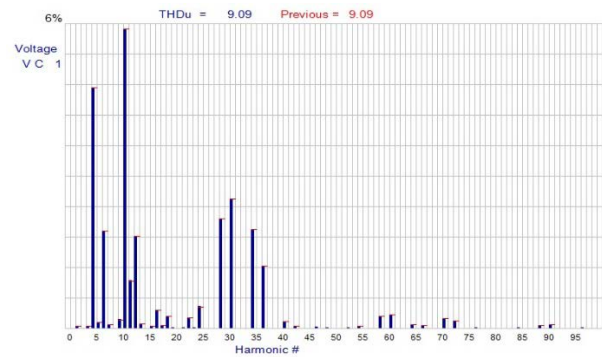
Fig. 11d Output Voltage Spectrum for Sinewave Filter tuned to 600 Hz operating at 2 kHz Switching Frequency

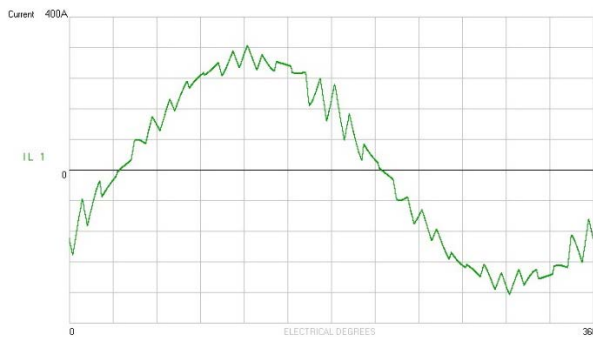
Fig. 11e Inverter Output PWM Current Waveform at 2 kHz Switching Frequency

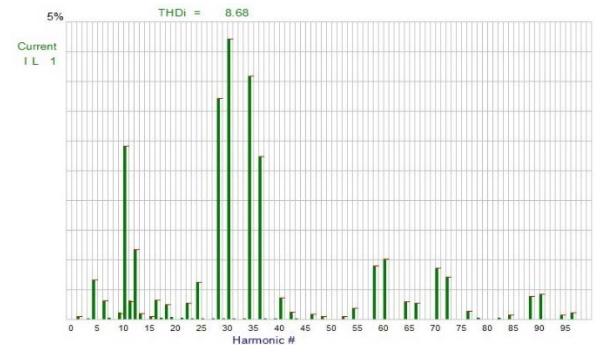
Fig. 11f Inverter Output PWM Current Spectrum at 2 kHz Switching Frequency

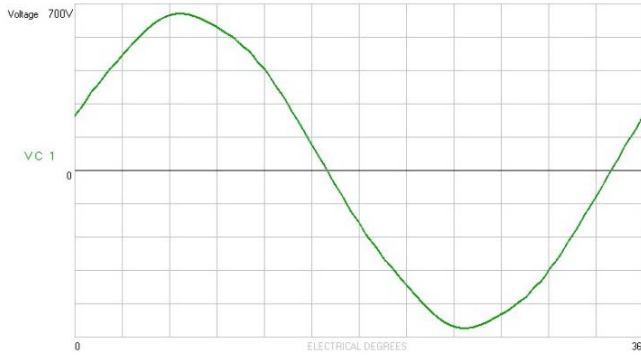
Fig. 12a Output Voltage Waveform for Sinewave Filter tuned to 180 Hz operating at 2 kHz Switching Frequency

Better performance was achieved when the filter was tuned near 180 Hz with no apparent system resonance even without resistors. Figures 12a and b show voltage waveform and spectrum at sinewave filter output for a 200 HP, 480V, 60 Hz filter tuned to 180 Hz with $vTHD < 2\%$. Similar results were achieved for the 1100 HP, 480V, 60 Hz ESP system. Other important improvements in performance included a very low insertion loss (ie. $< 3\%$ drop in voltage at full load) and improvement in PF to near unity at the inverter output.

As described in Section V, computer simulations for a design that matched the commonly accepted practice of tuning the filter to at least 10x the output frequency of 60 Hz (ie. 600 Hz), resulted in poor performance. Quite high levels of distortion remained in the output voltage of the filter (Fig. 11c and d). After performing several iterations, an optimal design tuned near 180 Hz was found to have excellent simulation results as shown in Fig. 12a and b.

Fig. 18a and b also show the measured output voltage of the new sinewave filter. Although the voltage distortion at 6.1% was higher than the simulation results (Fig. 12a), it was comfortably below the 8% recommended by IEEE Std 519, Recommended Practices and Requirements for Harmonic Control in Electrical Power Systems [12]. Also, there was no evidence of harmonics around the PWM switching frequency (ie. 33rd harmonic or 2 kHz) which confirmed the effectiveness of the filter. And this voltage distortion was much lower than the 28% distortion measured previously under 6-Step operation (Fig. 19a and b).

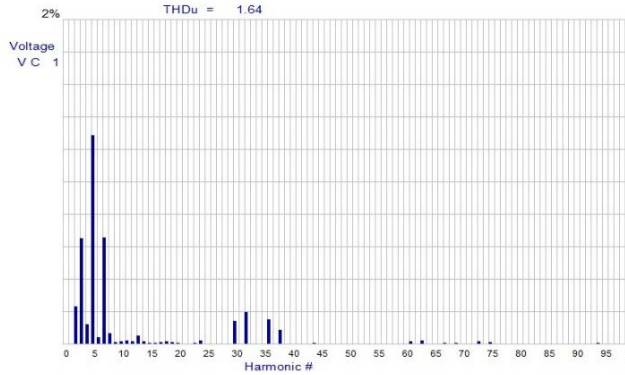
Fig. 12b Output Voltage Spectrum for Sinewave Filter tuned to 180 Hz operating at 2 kHz Switching Frequency

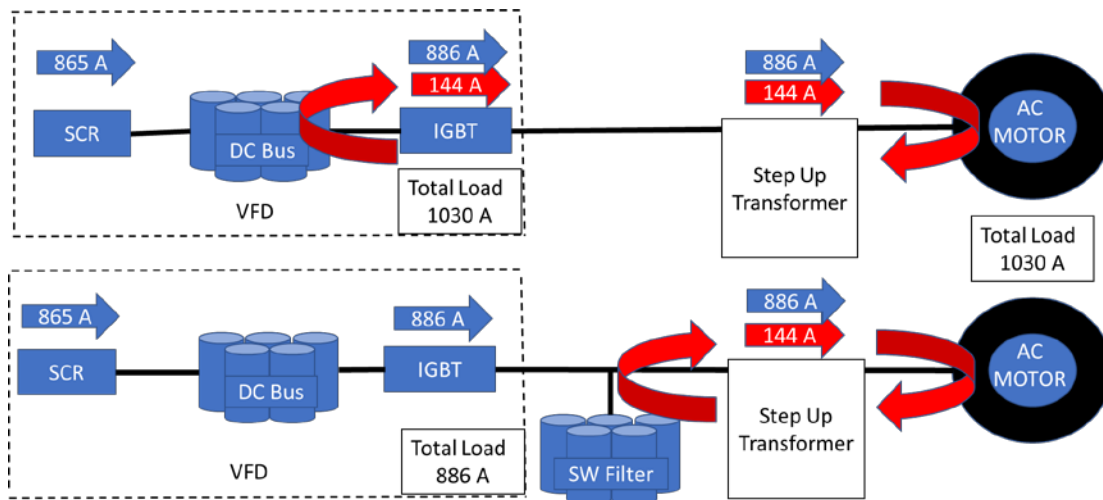
Fig. 13 Reduction in Inverter Current due to PF Correction at Sinewave Filter Input

One advantage of sinewave filters is that their capacitors provide some compensation for the inductive reactive power of the motor [10]. The proposed design goes a step further by nearly fully compensating for this inductive reactance resulting in a power factor (PF) at the inverter output of near unity. In the simulation for the 1100 HP filter, motor displacement PF was assumed to be 0.82. By adding the appropriate amount of capacitance, the PF upstream of the filter can be improved to 0.98 which can reduce the inverter current by ~14%. Fig. 13 shows the real power draw of 886A and 144A of inductive current at both the motor and inverter with no sinewave filter installed. With the sinewave filter, its capacitors now provide the 144A of inductive current removing that requirement from the inverter. The reduction in load current substantially offloads the inverter reducing its losses and extending life expectancy. The addition of the proposed sinewave filter could also allow for slightly larger downhole equipment to be utilized without replacing the VSD. Reducing the capital requirements for an incremental increase in production.

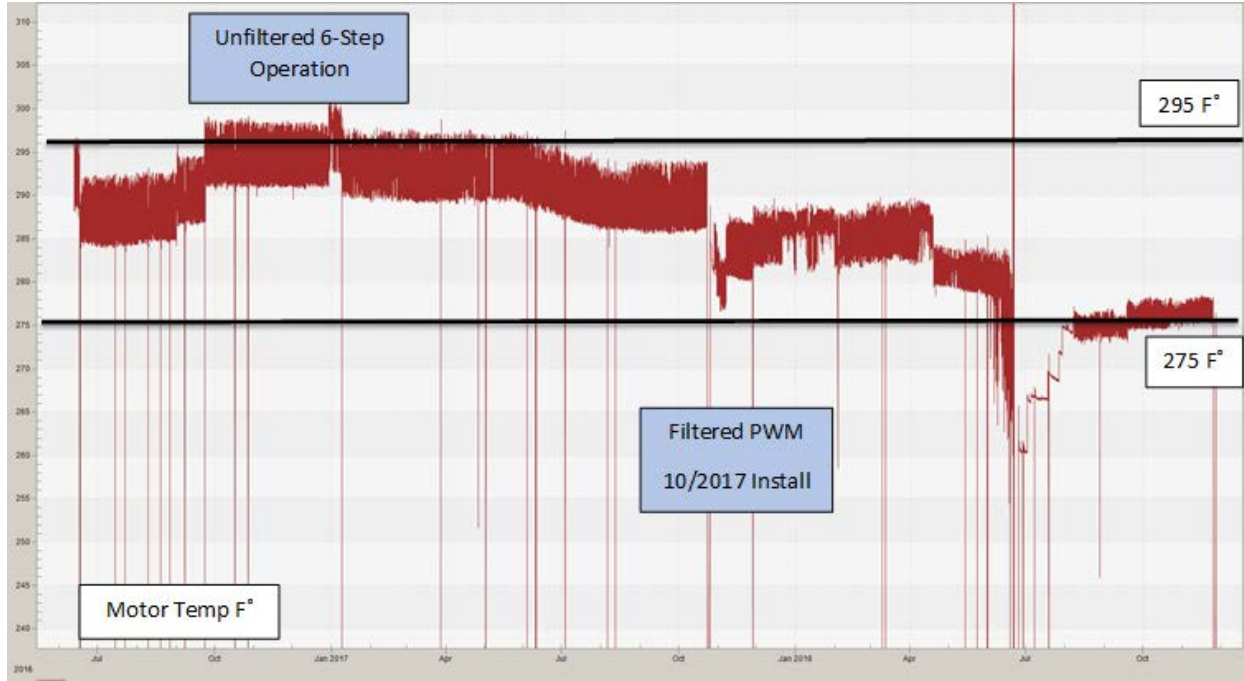
Fig. 14 Significant Drop in Operating Motor Temperature post Filter PWM install.

Fig. 14 shows the decrease in motor operating temperature while Fig. 15 shows the improvement in motor vibration that was achieved after the filter was installed. In addition to the increased oil production, this filtered PWM install also led to a record operating runtime (Fig. 23). Previously, the longest runtime record while running in unfiltered 6-step was 984 days. As of the writing of this paper, the well continues to run after 2,092 days. This type of runtime extension plays a significant impact in the OPEX cost associated with downhole failures as well as preventing unplanned downtime to operations.

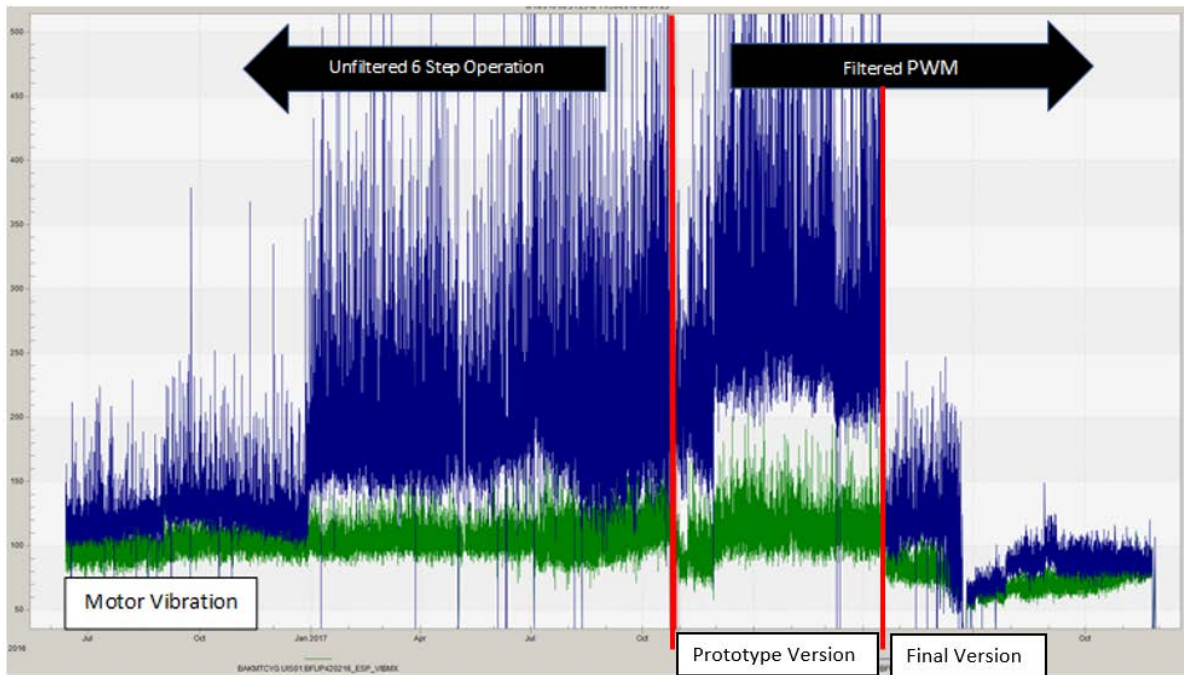
Fig. 15 Motor Vibrations were Substantially Reduced following Filtered PWM install

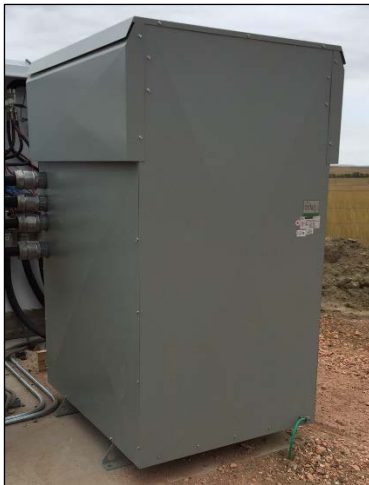
Fig. 16 1100 HP Sinewave Filter Installation

An 1100 HP, 480V, 60 Hz sinewave filter was designed with a tuned frequency of 180 Hz. After installing the new sinewave filter at the existing well, the ESP was restarted in PWM mode.

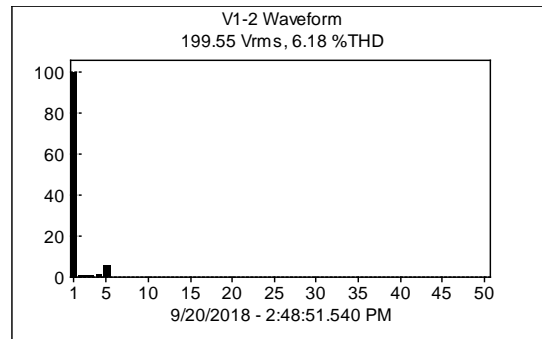
Fig. 18b Measured Output Voltage Spectrum for 1100 HP Sinewave Filter operating at 2 kHz Switching Frequency

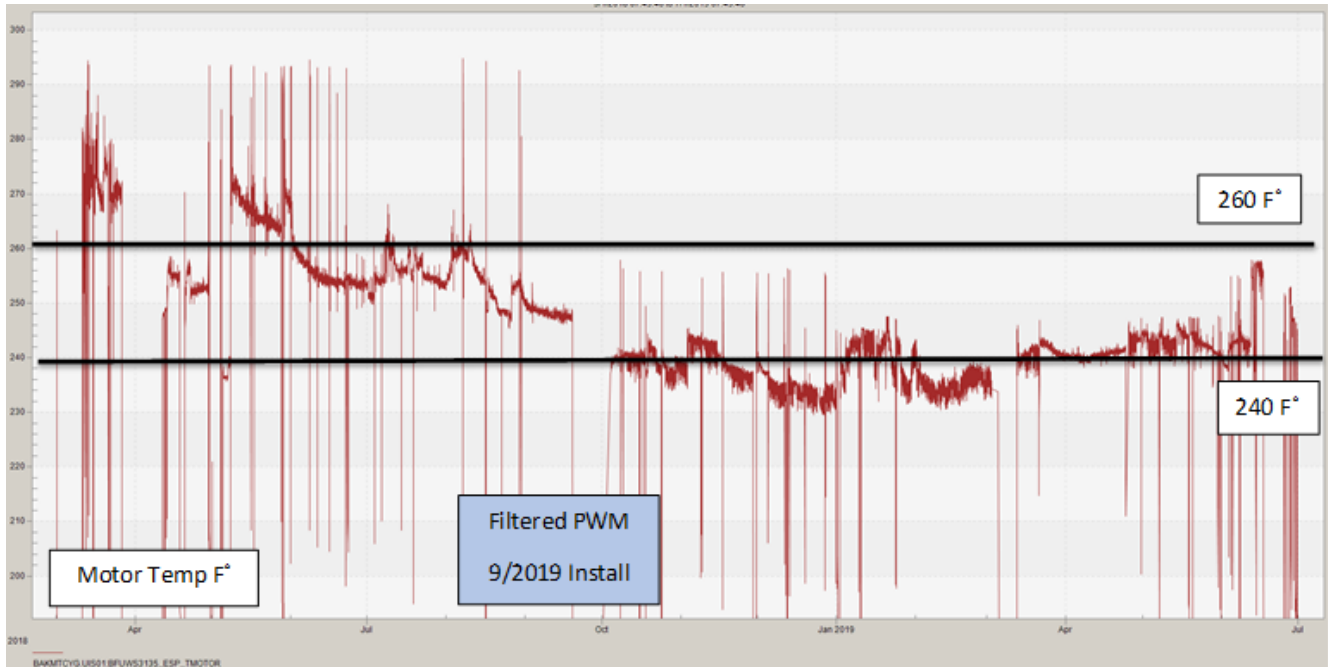
Fig. 20 Drop in Motor Operating Temperature during Start-up after Switching to PWM with Sinewave Filter

Almost immediately, a significant reduction in motor operating temperature was observed. Fig. 20 shows the drop in motor operating temperature after switching to PWM mode operation with the sinewave filter. The high spikes in temperature occur when the ESP has been restarted after being shutdown. Although momentary, these increases in motor temperature put substantial stress on the motor. These momentary temperature spikes are particularly detrimental to ESPs due to the impact on self-equalizing motor seals. Motor oil in the seal expands and is discharged into the well bore when the motor temperature rises and contracts as it cools, bringing well bore fluid into the seal. While to some degree the well bore fluid contamination in the seal is unavoidable, it is believed that eliminating severe temperature spikes will dramatically improve the life of the motor seal section. Motor seal failures are not typically thought of as an ‘electrical’ failure but electrical thermodynamics can have an impact on the mechanical integrity. After installing the sinewave filter and operating in PWM mode, the startup motor temperatures were reduced by nearly 40° F. This is especially important due to the reactive and volatile nature of a Water Source Well (WSW) operating in a mature waterflood.

Motor temperatures during continuous operation also dropped significantly from 260° F to 245° F or over 5%. Also, the measured voltage drop of < 3% across the filter while running at top speed was as per design. Previous sinewave filters introduced a voltage drop of around 10%. With a lower voltage drop, voltage to the motor was proportionately higher which decreased motor current and its associated losses. This contributed to the net reduction in motor operating temperature. Given these results, the well saw a dramatic improvement in runtime by 70%.

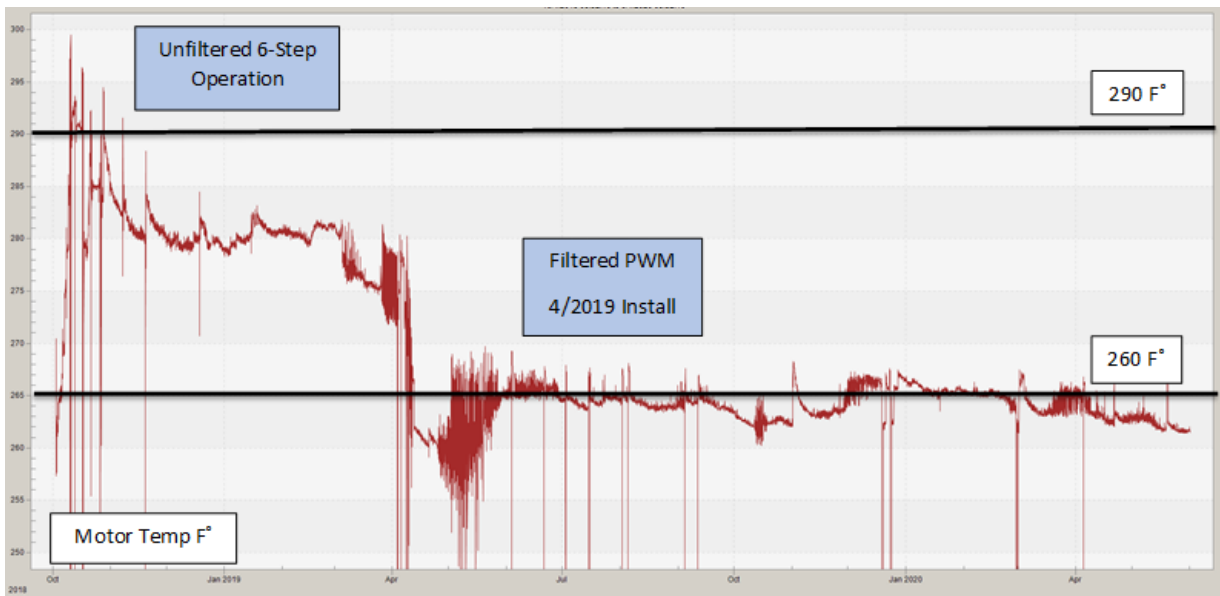
Fig. 21 After installing Sinewave Filter, the ESP Motor experienced a 25F° drop in Motor Operating Temperature

A filter was built and installed on an existing 250 HP well which originally was not equipped with a sinewave filter. At this site, the combination of reduced motor temperature and reduced VSD current, resulting from PF improvement, allowed the operator to increase well production by increasing VSD operating speed. The given well historically carried a higher fluid level than intended by the operator due to the motor temperature restriction. Previous efforts to increase production by increasing VSD operating speed resulted in excessively high motor temperatures requiring that the experiment be abandoned. Even at the increased VSD speeds, motor vibrations were substantially reduced (Fig. 22). The success in oil production increase inspired the operator to consider other well sites where increased production might be possible by simply installing a sinewave filter and increasing the size of the step-up transformer if required. This type of approach is especially important when you consider the scalability across the field. Not every well can cover the individual CAPEX to upgrade the system on surface and downhole. Once the filter was installed, it allowed the operator to achieve the highest operating frequency historically and improved the drawdown by 50%. Not only did surface runtime improve on the ESP system but the incremental oil gain led to production optimization.

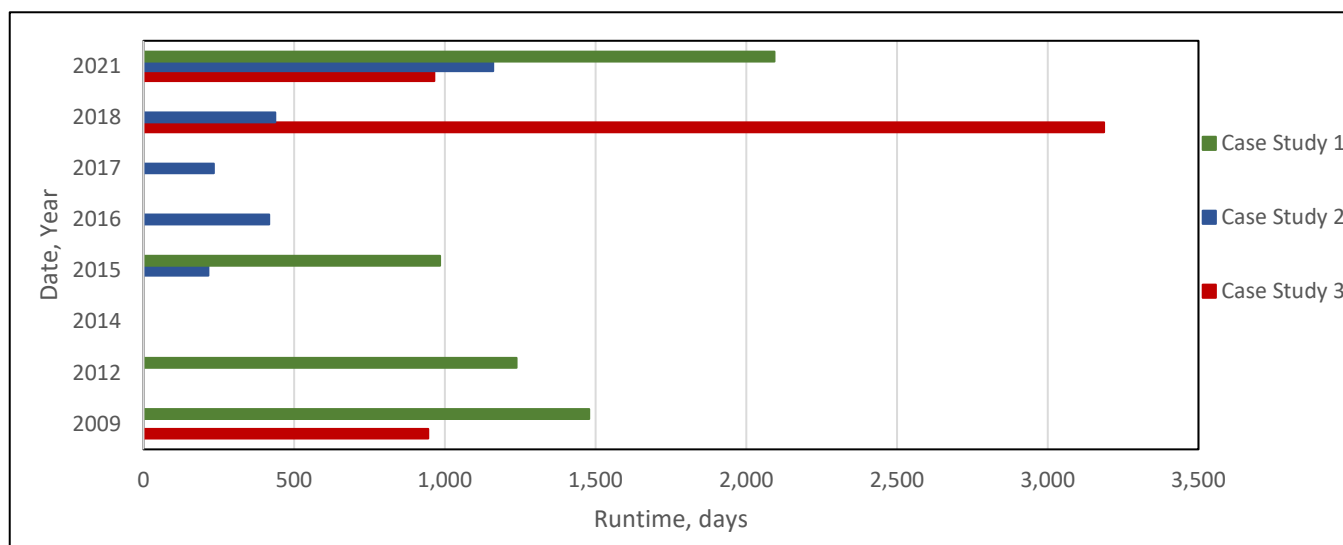
Fig 23. Runtime between Downhole Failures recorded for Three Case Studies. Case Study 1 & 2 both exceed previous Runtime Records after PWM Filter install (10/2017 and 9/2018 respectively)
